Elfin Hill Road Reserve Foreshore Stabilisation Concept Design Report

Gosford City Council

23 February 2015 Final 8A0467

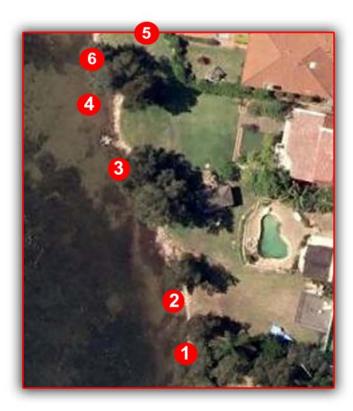
FIGURE 2 Area A

Area A is presented in Figure 2 and comprises of the following:

- Brick and concrete rubble of various size;
- Aluminium ramps used as a private launching ramp and 2 wooden planks thought to be used as a dinghy skid by another resident;
- Remains of a vertical 'piled' timber seawall, discontinuous, eroded behind piles and in a state of disrepair;
- Casurinas exposed at seaward base;
- Open eroded foreshore, around a 0.5 m scarp;
- Several local pvc drainage lines exposed;
- One reinforced concrete storm water outlet terminated at a headwall approximately 5m landward of MSL. Concrete channel and gabion to prevent erosion of the shoreline. Gabion is damaged with contents scattered along foreshore and signs of erosion in drainage channel;
- 150 to 250 mm angular sandstone blocks;
- Mangroves established in sediments on the rock shelf south of the site, one mangrove approximately 3 m tall was uprooted.

Casurinas exposed at based behind sandstone and concrete wall

Pipe terminated behind seawall and dilapidated gabion in foreground

Pipe terminated behind seawall and dilapidated gabion

Brick and concrete rubble along foreshore

Aluminium ramps, vertical logs wall and brick and concrete rubble

Casurinas exposed at base. Rockshelf at southern end of site visible in the

Inventory of shoreline blocks and rock suggests approximately 50 sandstone blocks varying in size between 150 mm and 250 mm in this area may be suitable for reuse in the foreshore stabilisation works.

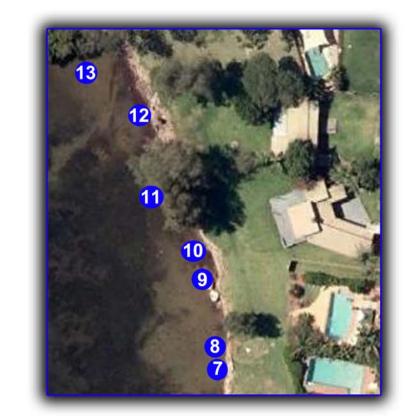
FIGURE 3 Area B

Area B is presented in **Figure 3** and comprises of the following:

- A sandstone block seawall comprising of approximately 200 mm to 300 mm square sandstone blocks mortared together on places, in reasonable condition. Signs of settlement and possible washout behind the wall;

- Access steps to the water constructed using bricks and concrete;
- Casurinas exposed at seaward base and two 100mm stumps indicating removal of casurinas;

- Remains of a log seawall, in poor condition;
- Open eroded foreshore, around a 0.5m scarp;
- Scalloped area on cleared shoreline thought to extend over rising main. Rising main not visible;

- Several local drainage lines exposed, two drainage lines have headwalls;
- Approximately 4 square meters of 20 to 50 mm gravel in front of one drainage outlet;

- 2 large 1.5 m diameter boulders;
- 2 large partly burnt stumps, dilapidated dinghy near the stumps;
- 200 to 300 mm angular sandstone blocks;
- Seaweed and debris deposits at the northern end of the site up to 300 mm deep;

Casurinas exposed at base

Scalloped area with 0.5m scarp. Rising main thought to lie underneath scalloped area

Large boulders and log wall to the left of the photograph. Log removed from wall visible behind boulder

Mortared sandstone blockwork wall

Local access steps at high tide

Inventory of shoreline blocks and rock suggests approximately 130 square sandstone blocks varying in size between 200 mm and 300 mm, approximately 80 angular sandstone blocks varying in size between 200 mm and 300 mm and 2 large 1.5 m diameter boulders may be suitable for reuse in the foreshore stabilisation works. Other material such as logs may be suitable for developing ecosystems.

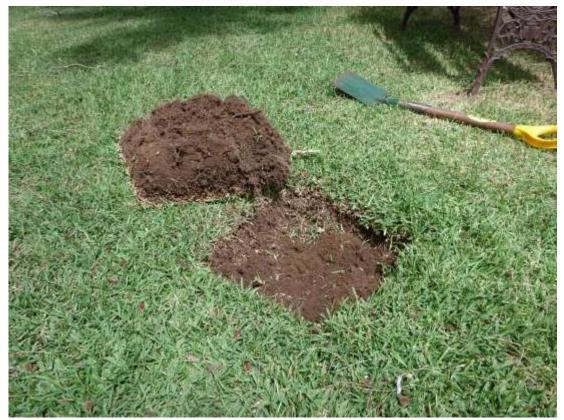
Photograph 1 – Shallow Test Pit behind the existing sandstone wall

The grass reserve appears to be reclaimed land that was once likely to have been an extension of the existing intertidal foreshore. A shallow test pit was excavated in an area where subsidence and washout was thought to be occurring (around 3 metres from the foreshore). The test pit revealed good quality topsoil and grass with a thick well established root system. **Photograph 1** shows the test pit behind the existing sandstone block wall.

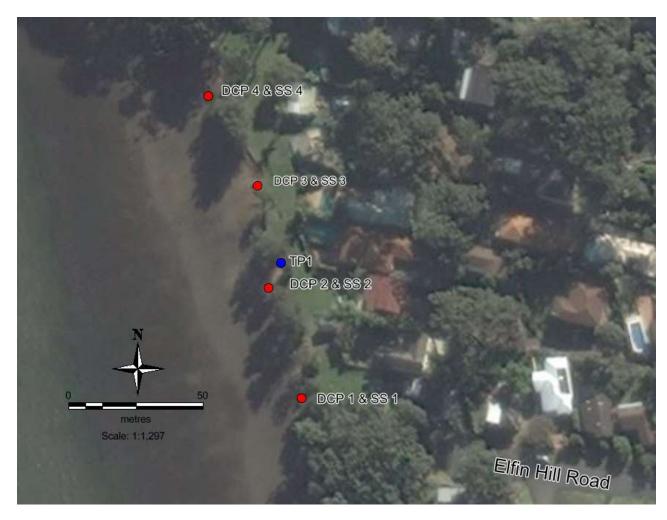
Figure 1 - DCP and Surface Sample Location Plan

Four DCPs were carried out along the foreshore to provide input into foundation conditions for various foreshore treatments. The DCPs were carried out to depths between 0.8 m and 2.6 m below the surface and generally indicated looser or softer material for the upper 0.7 m to 0.9 m with denser or stiffer material below. Bedrock was noted as foreshore rock shelves adjacent to the north and south of the site. Inferred depth to bedrock across the site varied between 0.7 m and 2.6 m. The DCPs results and a location plan are provided in **Appendix A**.

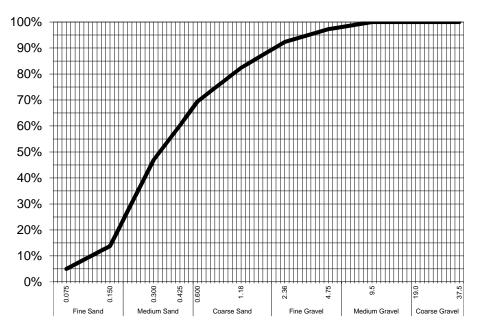
Particle Size Distribution

<u>CLIENT:</u>	Ben Morgan	DATE REPORTED:	7-Nov-2014
COMPANY:	Haskoning Australia- Royal Haskoning	DATE RECEIVED:	29-Oct-2014
ADDRESS:	Suite 505 100 Walker Street North Sydney, 2060	REPORT NO:	ES1423739-001 / PSD
PROJECT:	Elfin Hill Road Reserve	SAMPLE ID:	DCP 1

Four sediment samples were also collected and analysed for particle size distribution (PSD). The sediment sample results indicated that the middle and southern end of the site comprises medium grained sand with silt and traces of gravel. The samples have less than 10% fines (silt and clay sized sediments) and less than 8% gravel. The northern end of the site comprises silty sand with gravel and the sample has 22% fines and 23% gravel. The PSD results are provided in **Appendix A**.

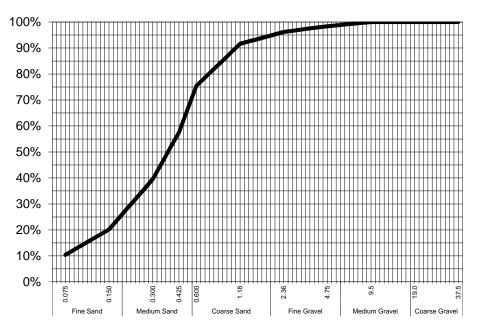
Particle Size Distribution

Particle Size (mm)	Passing
19.0	100%
9.5	100%
4.75	98%
2.36	96%
1.18	92%
0.600	75%
0.425	58%
0.300	40%
0.150	20%
0.075	10%

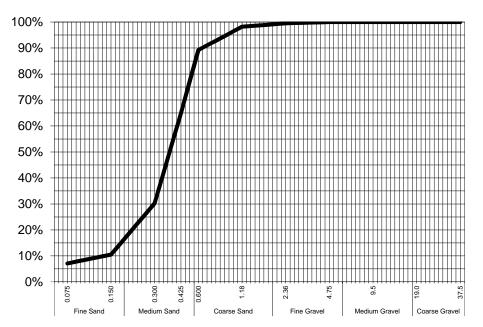
Particle Size Distribution

CLIENT:	Ben Morgan	DATE REPORTED:	7-Nov-2014
COMPANY:	Haskoning Australia- Royal Haskoning	DATE RECEIVED:	29-Oct-2014
ADDRESS:	Suite 505 100 Walker Street	REPORT NO:	ES1423739-003 / PSD
PROJECT:	North Sydney, 2060 Elfin Hill Road Reserve	SAMPLE ID:	DCP 3

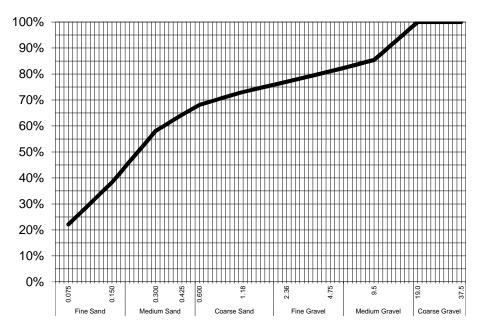
Particle Size Distribution

Particle Size (mm)	Passing
19.0	100%
9.5	85%
4.75	81%
2.36	77%
1.18	73%
0.600	68%
0.425	64%
0.300	58%
0.150	38%
0.075	22%
